## Grosvenor Gardens House: 150 years in the making

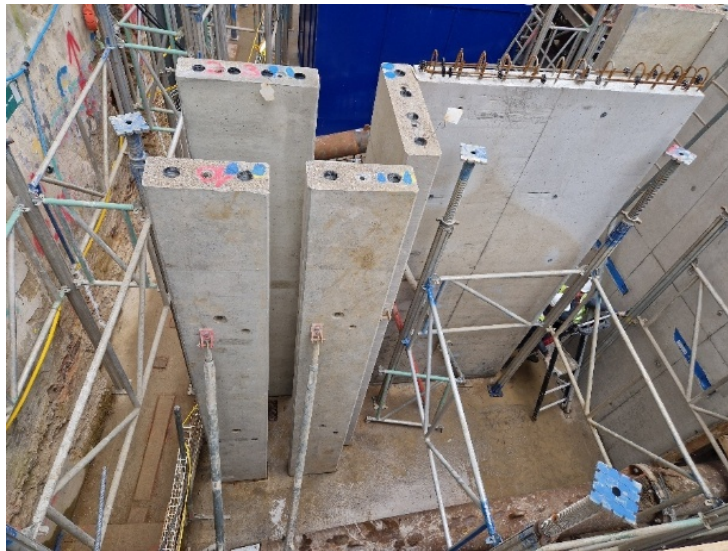
Figure 4: Core construction in progress on site, precast columns with dowel holes in top, in-situ wall with exposed reinforcement to right

With the Contractor appointed, their key driver was programme. We assessed the viability of changing columns and core walls to precast columns for erection speed. The governing factor was the dowelled connection capacity for moments and robustness, so some lower in-situ walls were retained. There were several drawbacks to changing to precast after detailed design. Some in-situ columns that were rotated or moved slightly on plan to optimise architectural layouts now have complicated end connections. The precast columns were made with a higher concrete grade than designed to accelerate curing and delivery. Without time for reinforcement redesign, this increased embodied carbon. Embodied carbon measurement during design is improving, but with Contractors driven by programme, design figures can mask reality.

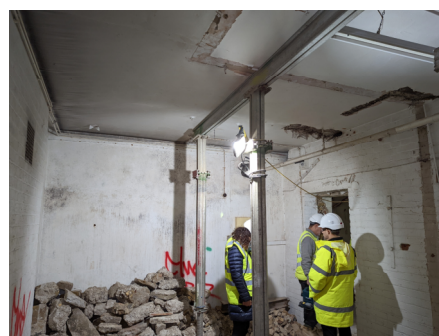
Figure 5: Pool area showing basement walls removed in red, retained in grey and new steel in blue, left photo before construction, right photo August 2025

Several existing walls were removed to accommodate a pool in the retained basement. Steel box frames transfer load and lower the slab by 3 m. To avoid damaging the existing building, the construction sequence was critical. A close working relationship with the Subcontractor facilitated this. We removed the bottom steel beams from the concrete capping beam to simplify installation and developed a jacking option for if cumulative deflections were excessive. Following lower-than-expected ground capacity tests and a sequence change, we redesigned the pool foundations from ground-bearing to loading the temporary piles. This required localised increased reinforcement but otherwise did not increase material volumes as the piles were designed to take the building weight. Collaboration and clear definition of load paths enabled us to overcome this unexpected unknown.
