## Hanging by a Thread: Saving the Tone Works Tank from Collapse

Tone Works is a former textile works in Wellington, Somerset. It was built by the Fox Brothers between 1830 – 1913 to wash, mill and dye cloth. Deterioration of the buildings and asbestos contamination led to abandonment of the 2-acre site in 2000.

A small part of this project lies in the Dye Store, a brick and stone masonry building which was retrofitted in the 19<sup>th</sup> century with a cast-iron tank at first floor level. Constructed in-situ from large panels, it measures 11m

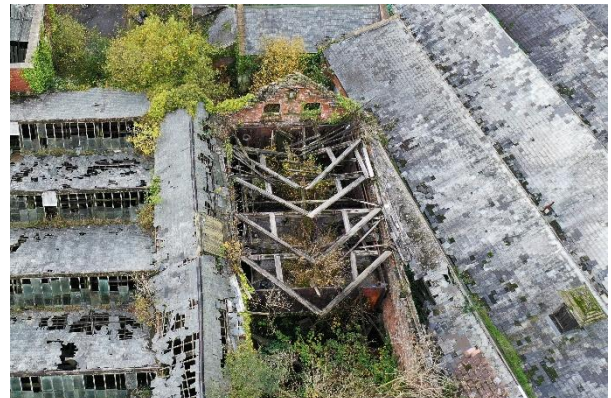
*Figure 1 The tank was obscured by the collapsed roof trusses, debris and vegetation*

The beams, columns and props supporting the tank were decaying after decades of water ingress, the roof having collapsed some 30 years ago. Collapse of the tank was a real possibility. One beam had already failed, causing large cracks to appear in the cast iron. If the tank did fall, it would destroy the adjacent buildings.

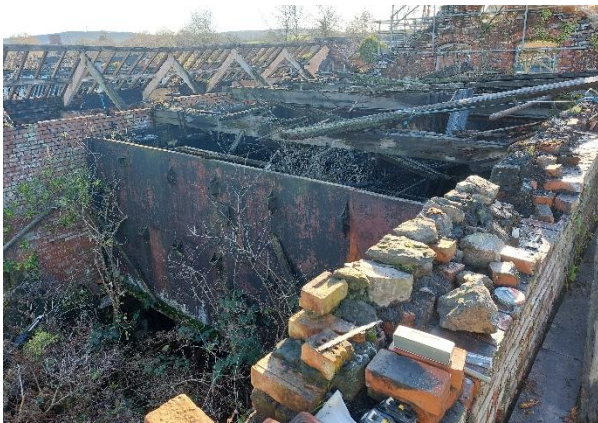
Figure 2 The adjacent buildings provided limited access

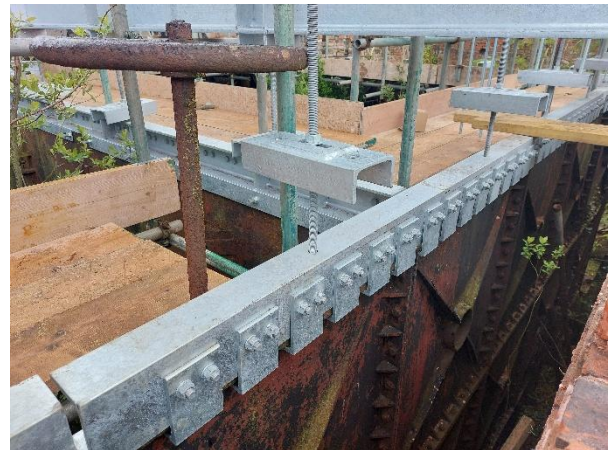
The clamps comprise a 2m length of PFC bolted to 14 unequal angles, which are used to avoid existing gussets. The PFCs were

limited in length to make them easier to handle and to overcome the slight curvature of the tank walls on plan. The PFCs are designed in bending to transfer the line load from the walls back to a pair of hangers.

When supporting the tank's weight, the clamp would exert a small bending moment on the panel flanges. Knowing cast iron is a brittle material, we were cautious in limiting the bending stress and sought guidance from the *Historical Structural Steelwork Handbook*. An allowable stress of  $18\text{N/mm}^2$  was selected and the clamp was used around the full perimeter, thus spreading the load, to meet this stress limit.

Figure 5 Clamps installed to the tank walls

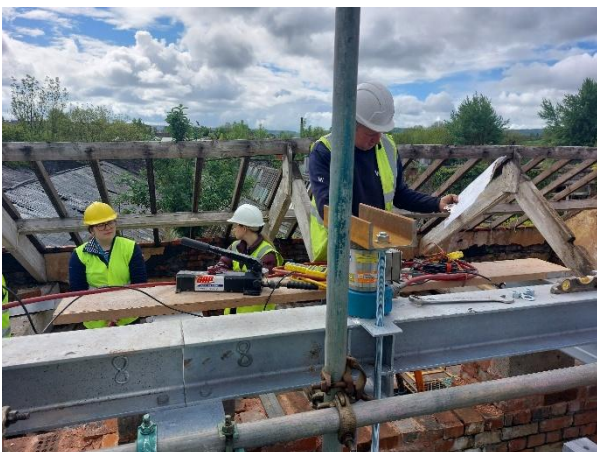
These were moved between hangers in sequence to tension them to 50%, 75%, 90% and 100% load. This incremental loading ensured the whole system was tensioned evenly. At each stage, the nuts connecting the hanger rods to the beams were simply tightened.

Figure 7 Temporary jacking arrangement

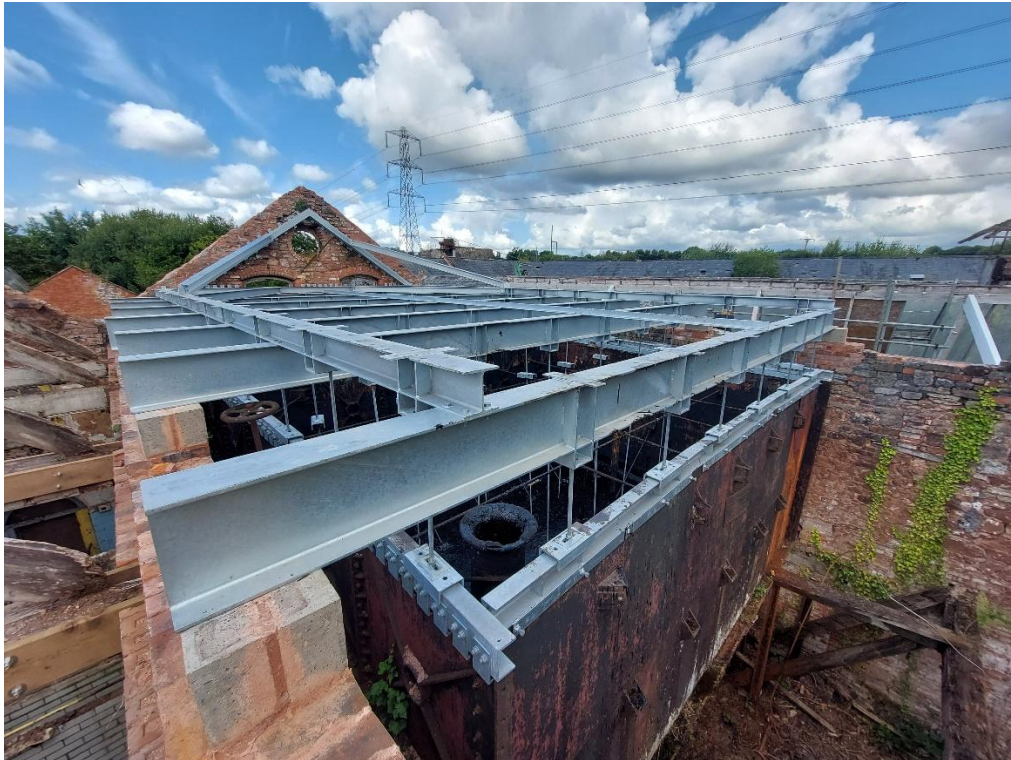
Seven primary steel beams span over the tank between the existing walls. Secondary beams span perpendicular to these and are aligned with the tank walls below. Sixty-two threaded rods hang from the beams to suspend the tank.

*Figure 9 The completed structure*
